## Photo of Washed Out Canal Bridge Reveals Little-Known Canal Break

By Bill Poray, Perinton Town Historian

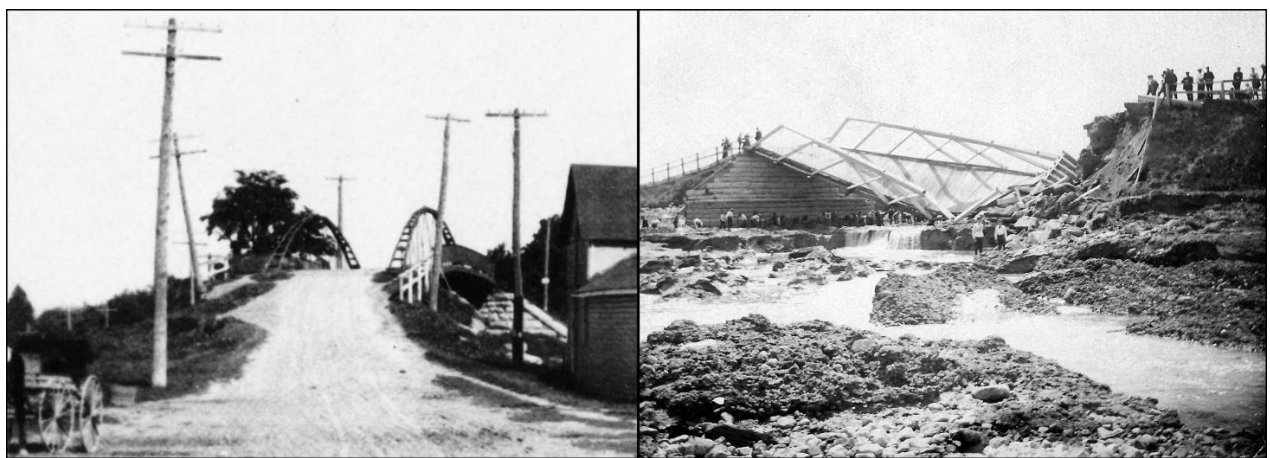
*The photo at left is of the bridge that carried Marsh Road over the canal at Bushnell's Basin, taken prior to it being washed out during the canal break of May, 1911. The photo at right shows the collapse of a different bridge due to a break in the canal. The photo was long ago attributed to the 1911 Bushnell's Basin break, but it is obviously a different bridge than the one pictured on the left. (Photos from the collection of the Perinton Historical Society)*

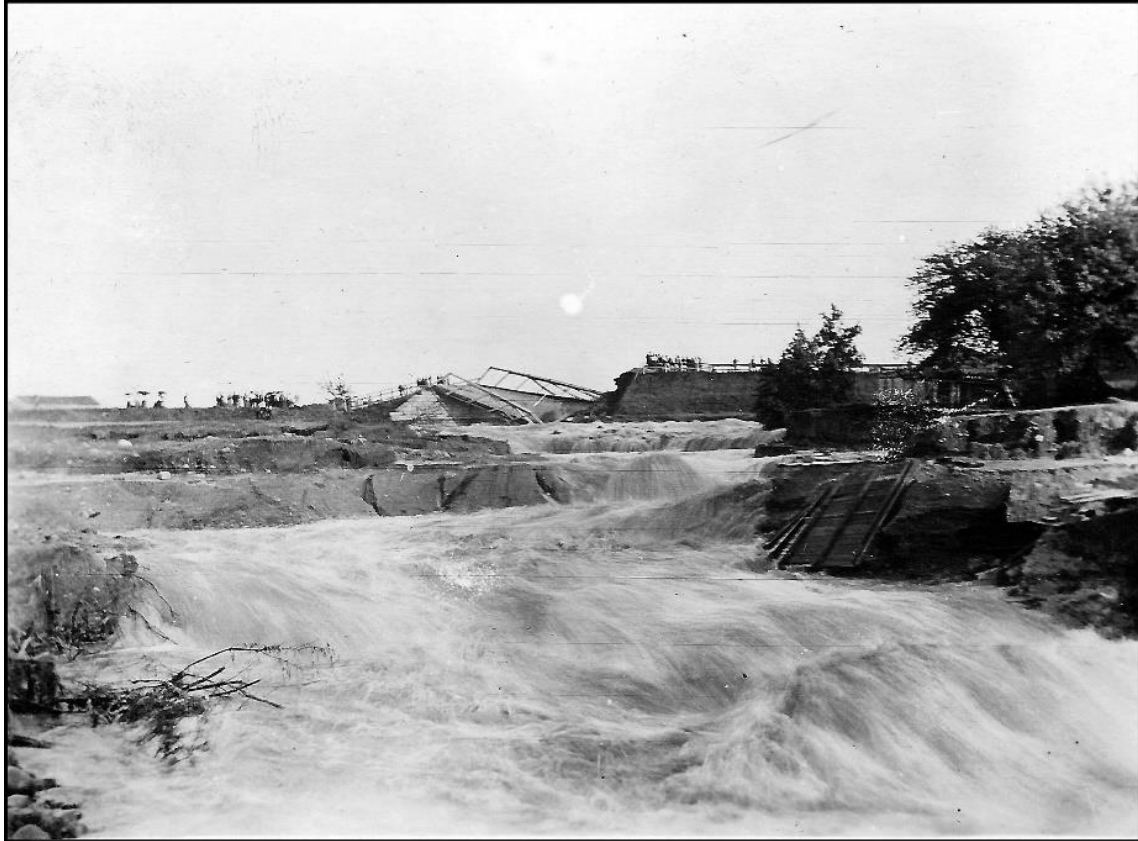
In an effort to unearth the identity and location of the mystery bridge, additional research led to a little-known canal break on May 26, 1908. As reported in the Monroe County Mail, "The break occurred just at the north end of the Wapping Road Bridge, the first bridge southwest of the Oxbow and about a half mile beyond it. The towpath is entirely carried away for a distance of about one hundred feet and the bed of the canal badly washed out for half of its width. The bridge is a total wreck." The western portion of Ayrault Road was once called Wapping Road.

As for the cause of the break, as with other similar incidents, a burrowing muskrat was suspected to have compromised the integrity of the canal's bank. No specific muskrat stepped forward to accept responsibility for the damage, and no charges were ever filed.

*A view looking south at the collapsed Wapping Road Bridge on May 26, 1908. The western portion of Ayrault Road was once called Wapping Road. The bridge was replaced with a Double Warren truss bridge of steel construction the following year.*

The destroyed bridge was replaced in 1909 by a single lane bridge of steel construction, which was replaced in 1989 by the current bridge. A chart created by a New York State agency with information on all the canal bridges in our area confirmed that the replacement bridge was built in 1909. This is two to three years before other canal bridges in our area were replaced as
